Rainbow School Nerok Zanskar Multi-Purpose Auditorium Hall Progress Report 2025

Construction Report No2

- ❖ Report on Multi-purpose Auditorium Hall from 22nd June to 2nd of September 2025

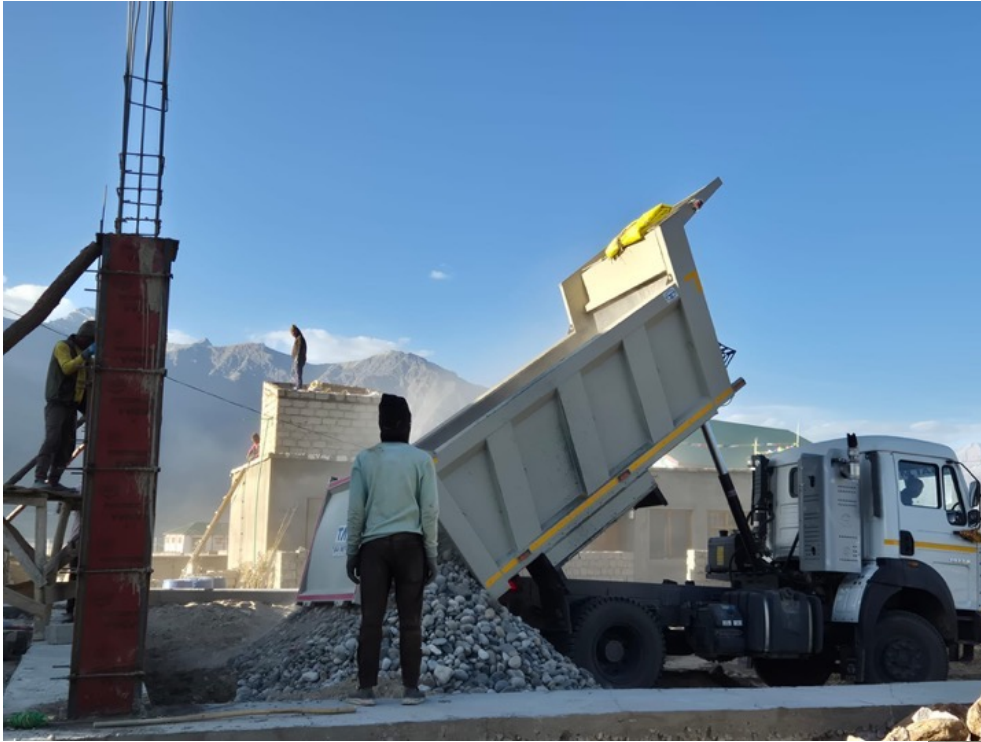
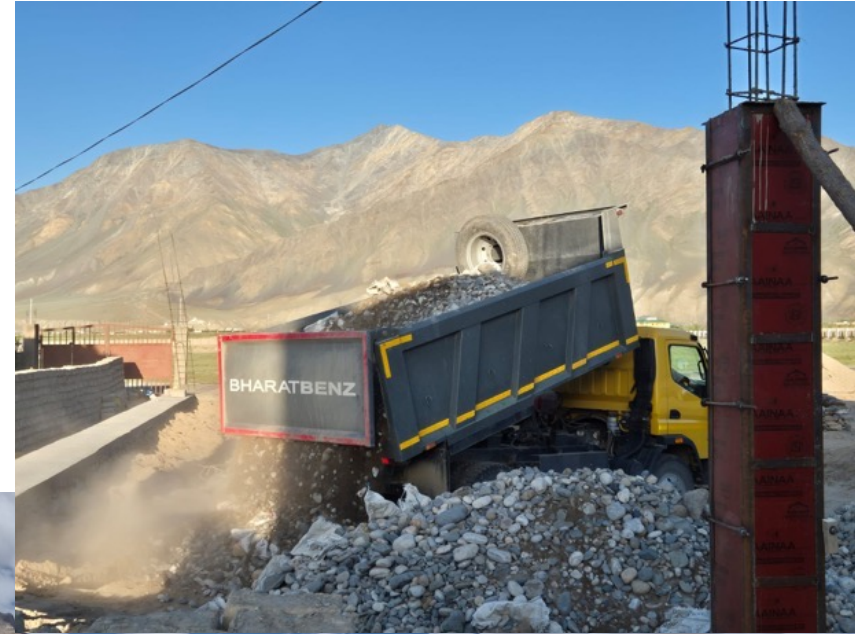
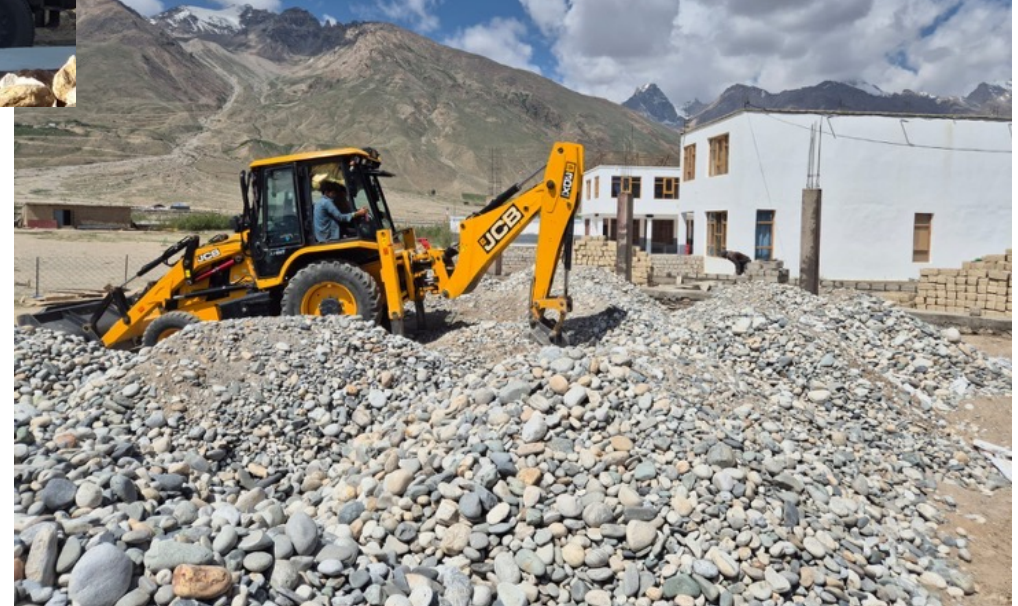
Filling of Foundation

After raising the foundation up to 3 feet above ground level, we have started filling the foundation with gravel of random sizes. The filling is carried out with proper levelling using shovels, and labourers have ensured an even surface. On top of the gravel filling, insulation will be provided using straw-clay bricks, followed by a 4-inch layer of PPC (Portland Pozzolana Cement). Finally, the structure will be completed with finished wooden flooring.

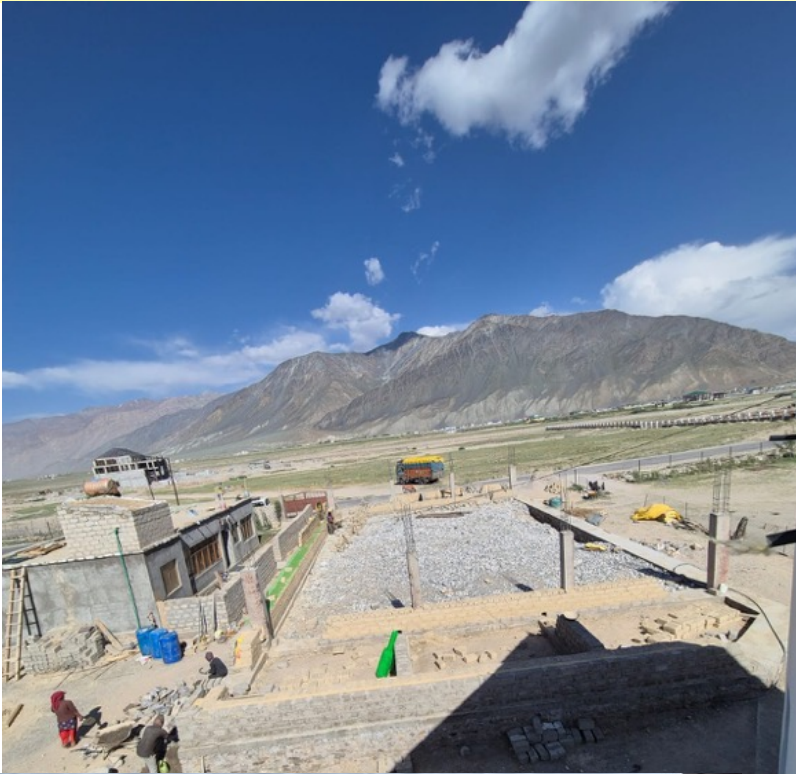
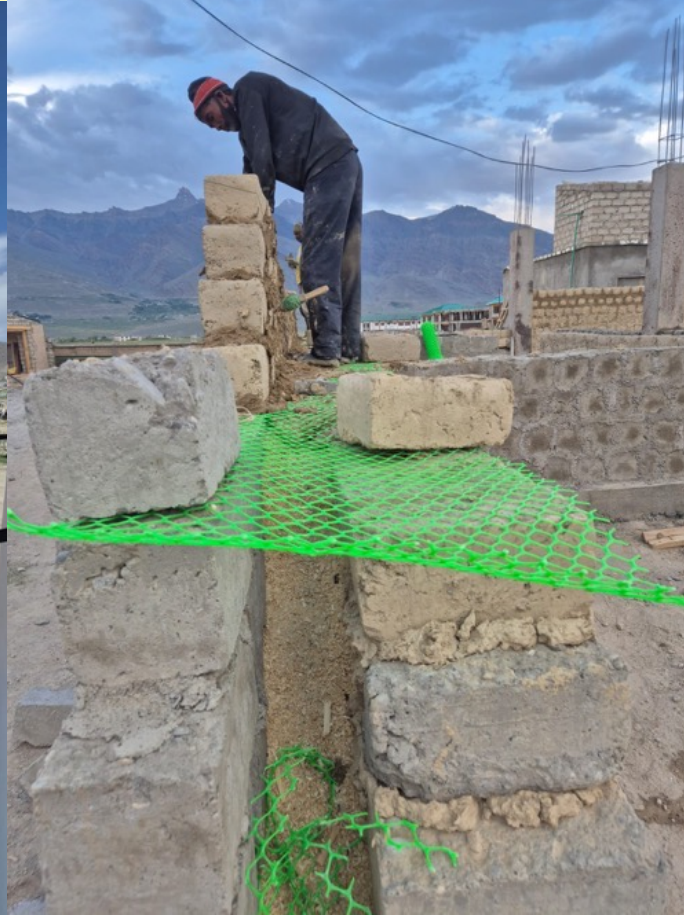
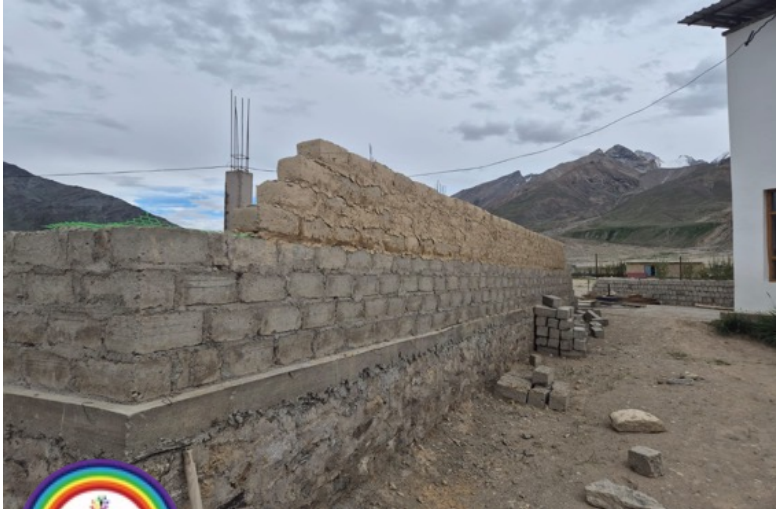
Wall Construction

The walls are being constructed using a cavity-wall system. The cavity is filled with sawdust, which serves as an insulation material. The sawdust is compacted (rammed) in layers to achieve the required density and stability, resulting in a total wall thickness of 24 inches. To enhance structural integrity, geo-mesh reinforcement is installed at every 4 feet of height, effectively tying the two wall leaves together and ensuring overall strength and durability of the wall system.

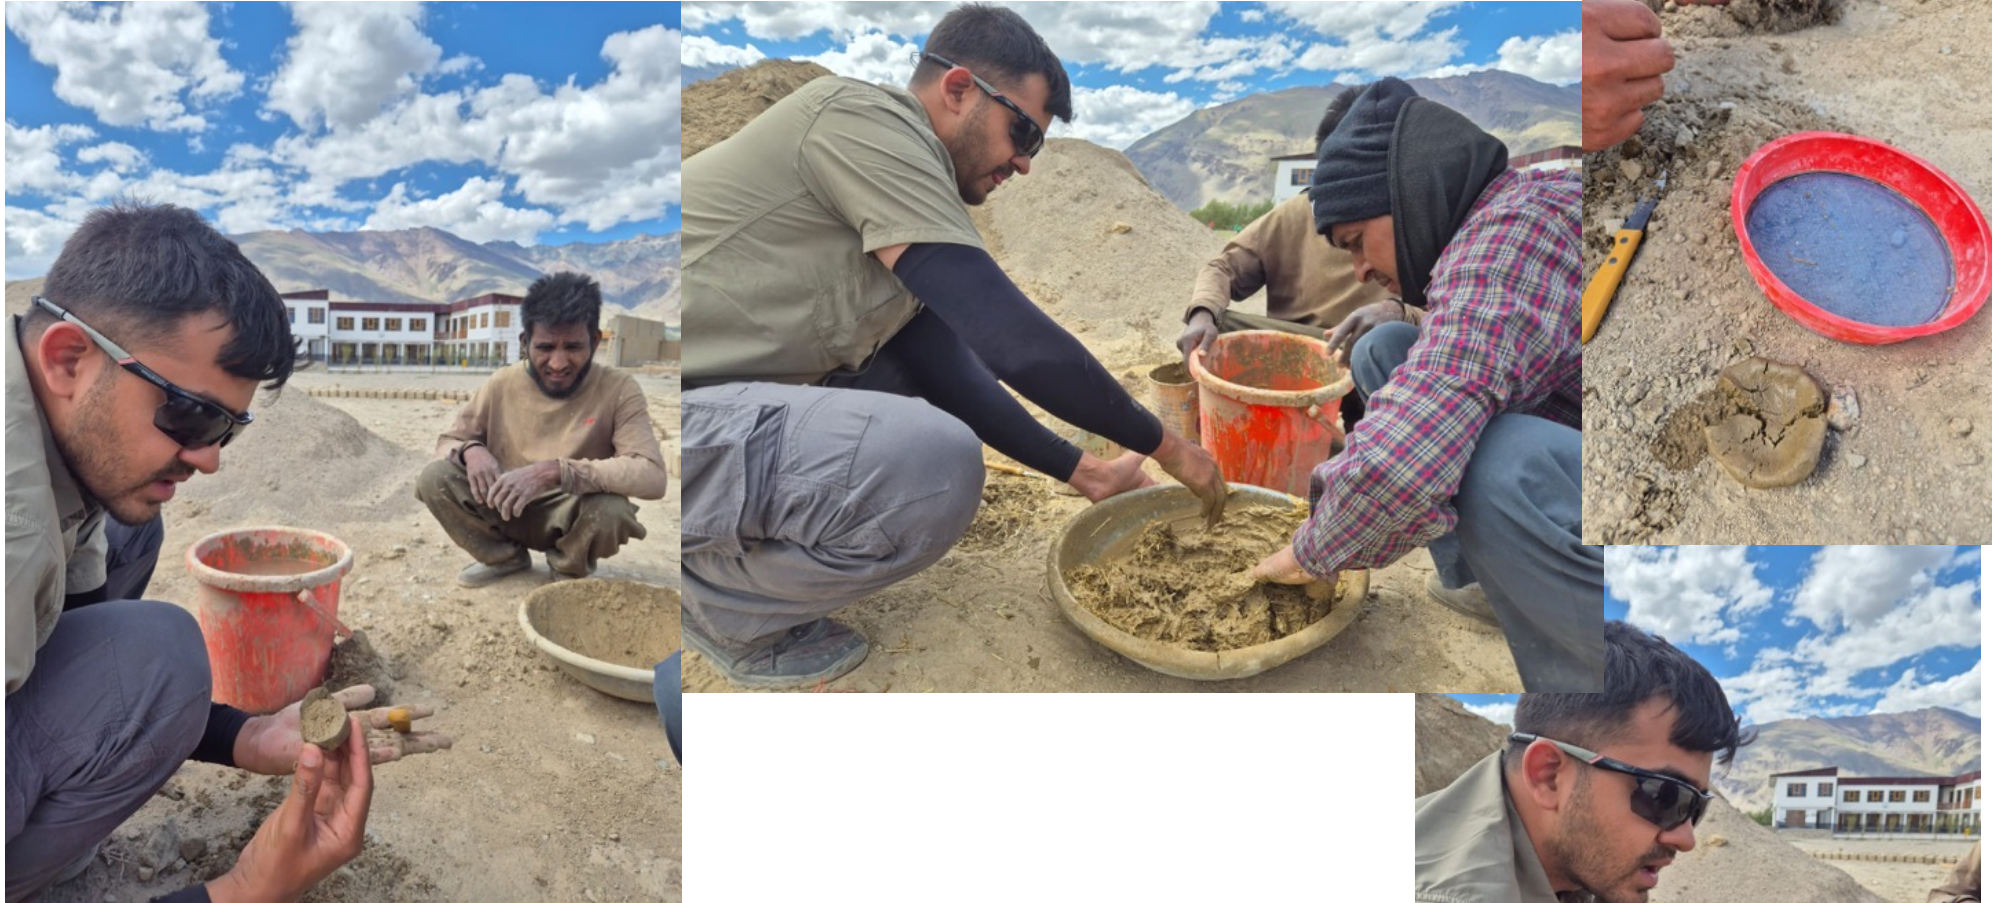
Soil Testing

Soil testing was carried out under the supervision of **HAIL Architect, Mr. Shubham Ray**, in coordination with **Contractor, Mr. Deb Bahadur Sunar**. The primary objective of the testing was to determine the relative proportions of clay, silt, and sand in the locally available soil, in order to identify its suitability for the production of high-quality mud bricks as well as for compacted straw–clay bricks.

Different testing methodologies were applied to evaluate soil composition and performance, ensuring optimal mix ratios for strength, durability, and workability in brick preparation. The results will guide material selection and standardization for subsequent construction activities.

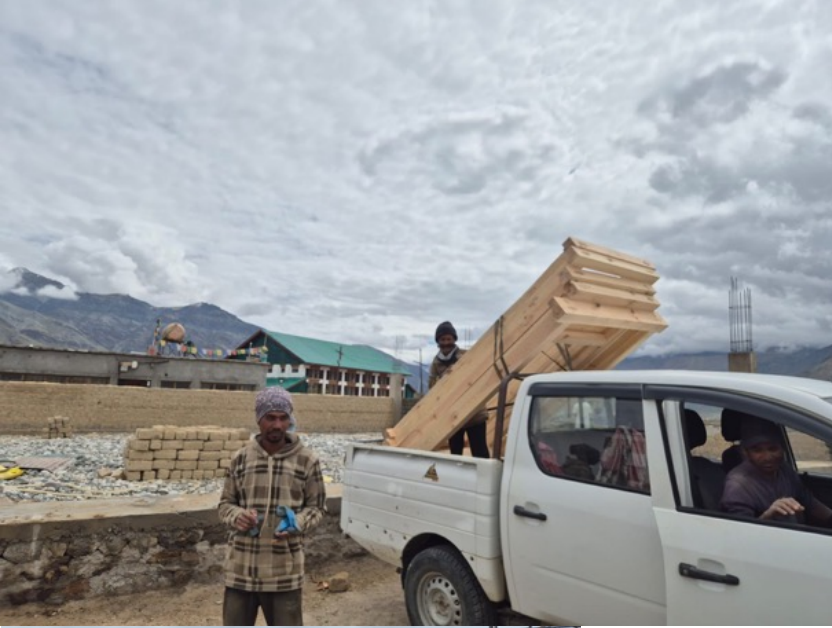
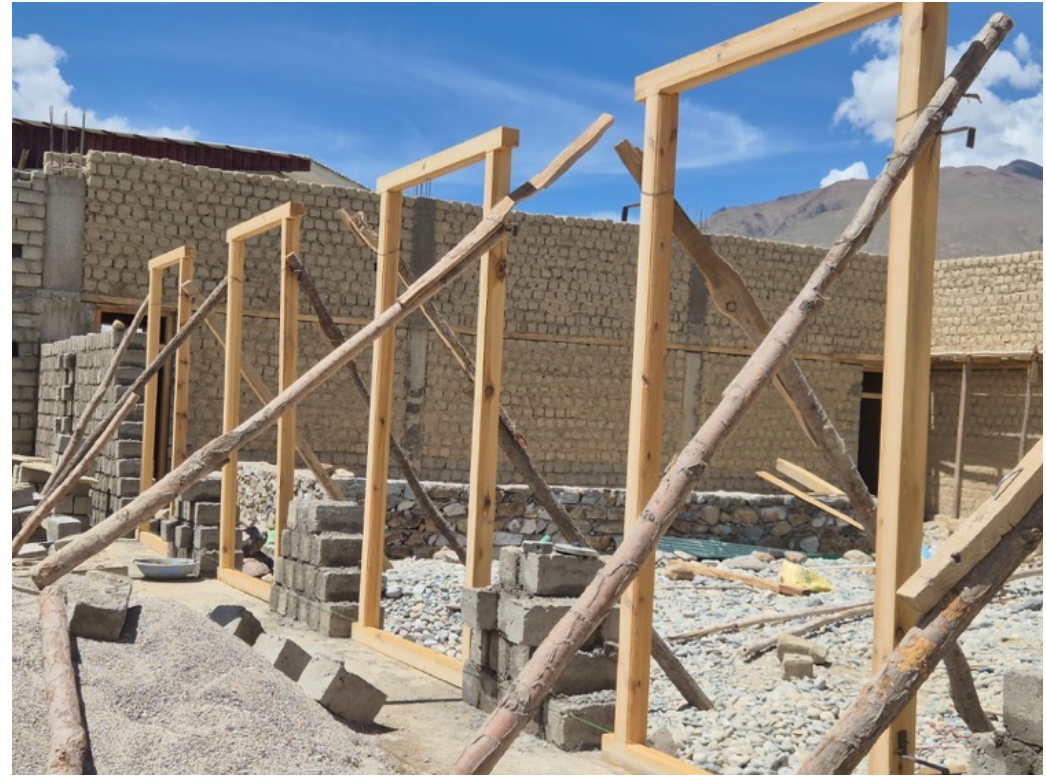
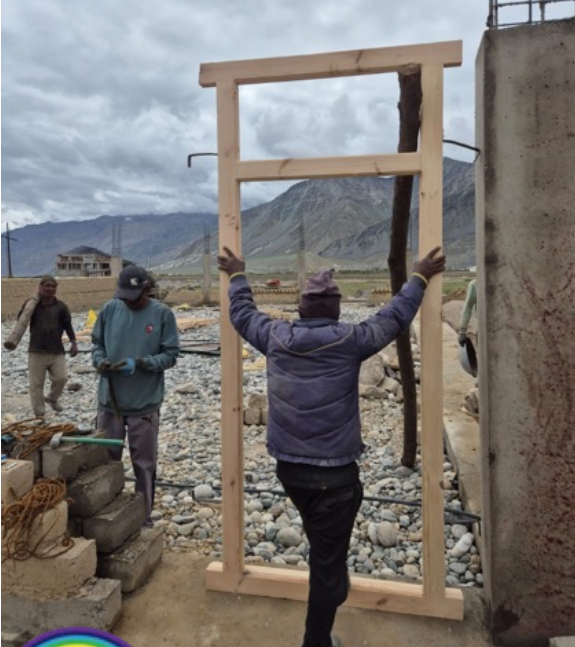
Installation of Interior Windows and Door Frames

The installation of interior window and door frames has been initiated as per the approved architectural layout. Frames are aligned vertically and horizontally using water levels and plumb lines to ensure accuracy in placement. Proper anchoring methods are employed to secure the frames firmly within the wall cavities, thereby maintaining structural stability and alignment.

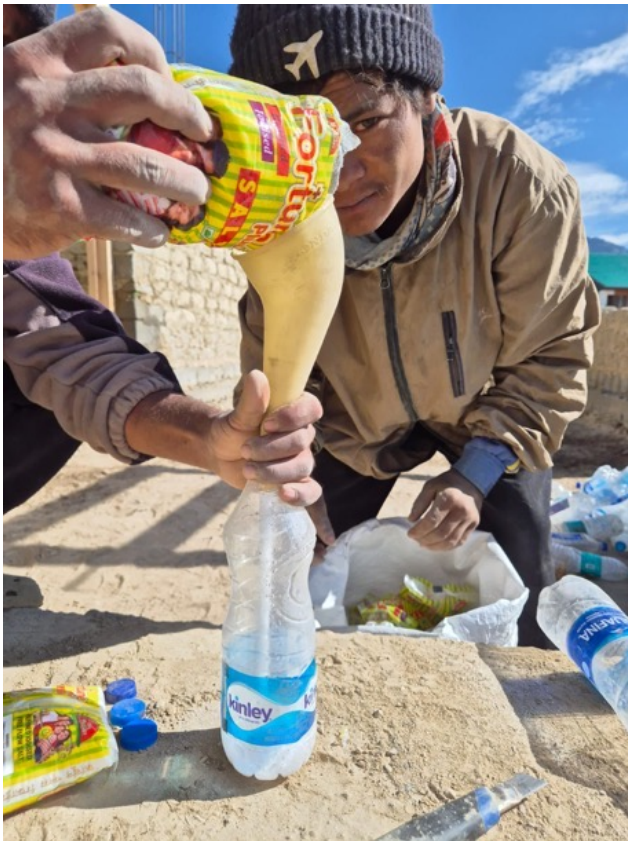
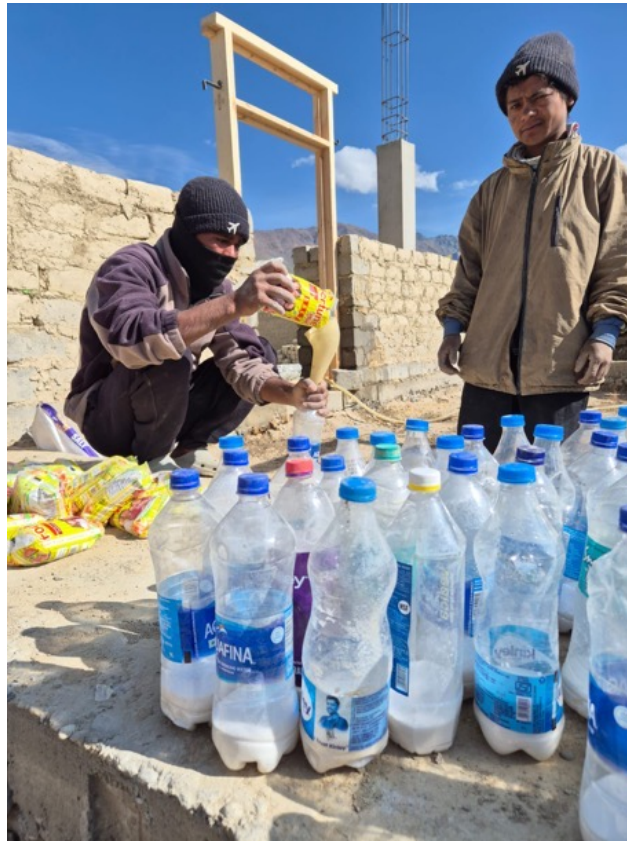
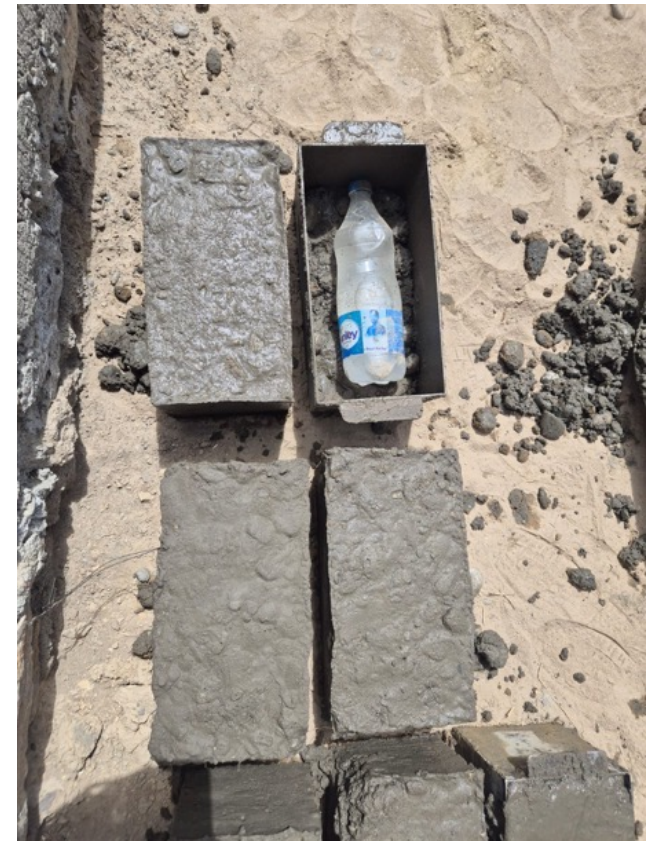
Fabrication and Placement of Thermal Bricks

Workers carefully prepare thermal bricks by filling empty plastic bottles with salt and subsequently adding water to enhance their thermal mass. These filled bottles are then cast into concrete blocks, forming composite thermal bricks.

The thermal bricks are strategically installed along the **south-east facing walls** of the building to maximize heat retention and improve overall thermal performance. This method not only contributes to passive heating but also incorporates waste materials into functional construction elements, supporting both sustainability and energy efficiency objectives of the project.

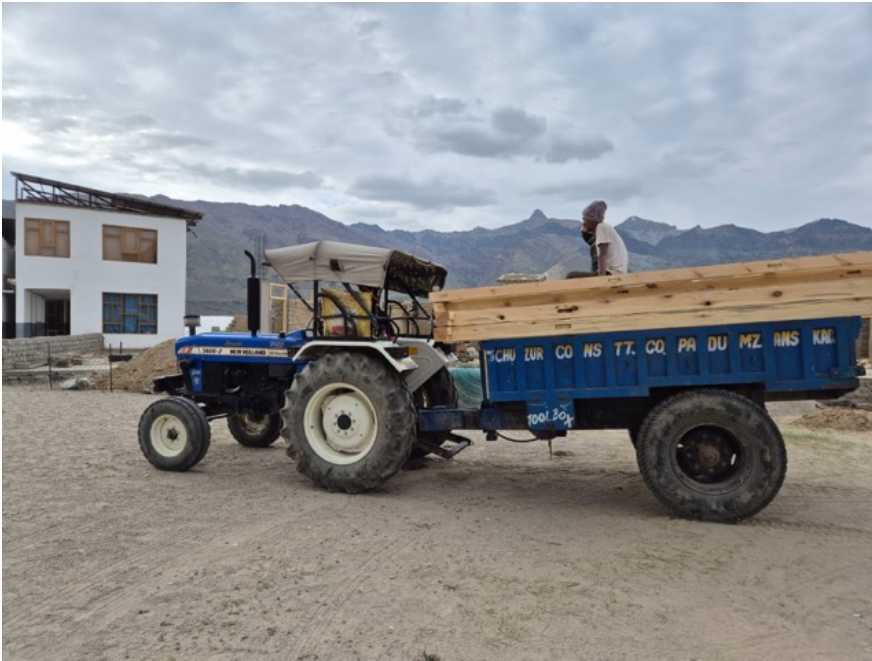
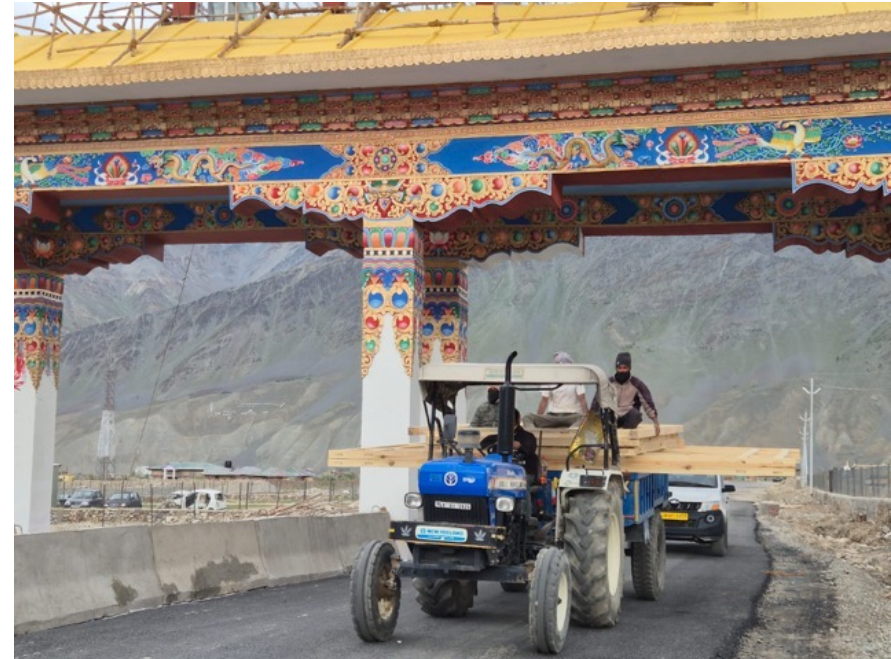
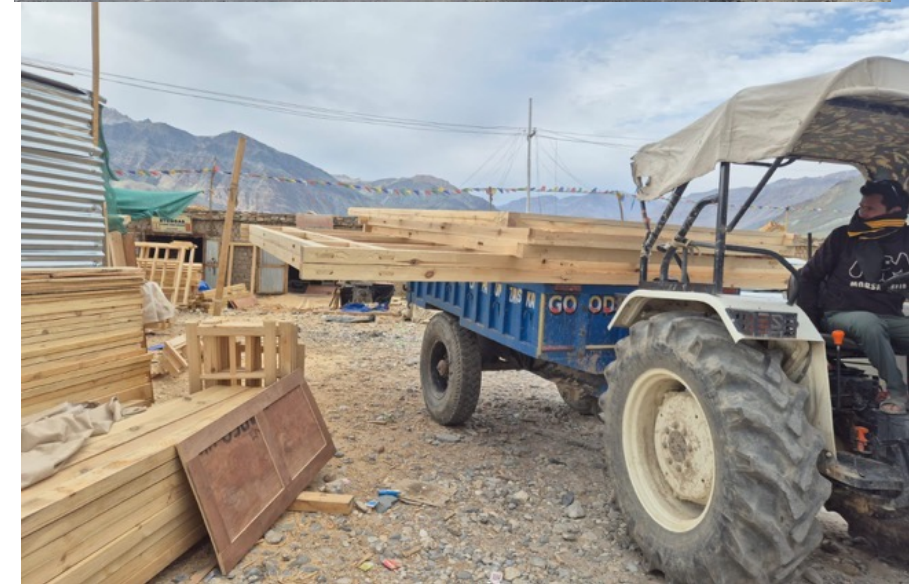
Transportation of Exterior Window Frames

Exterior window frames, fabricated at the local workshop as per approved design specifications, have been transported to the construction site. Care was taken during handling and transportation to prevent damage, bending, or warping of the frames. The frames will undergo inspection upon arrival to verify dimensional accuracy, surface finish, and structural stability prior to installation. This step ensures quality compliance and readiness for integration into the building envelope.

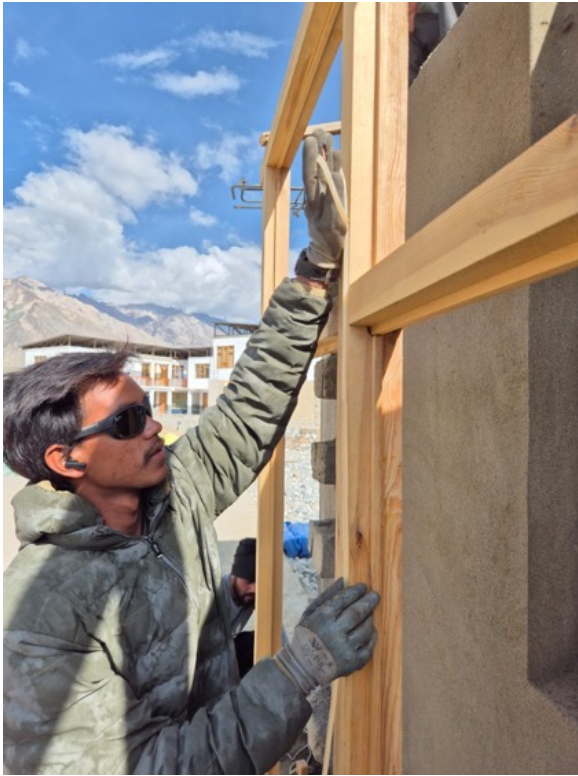
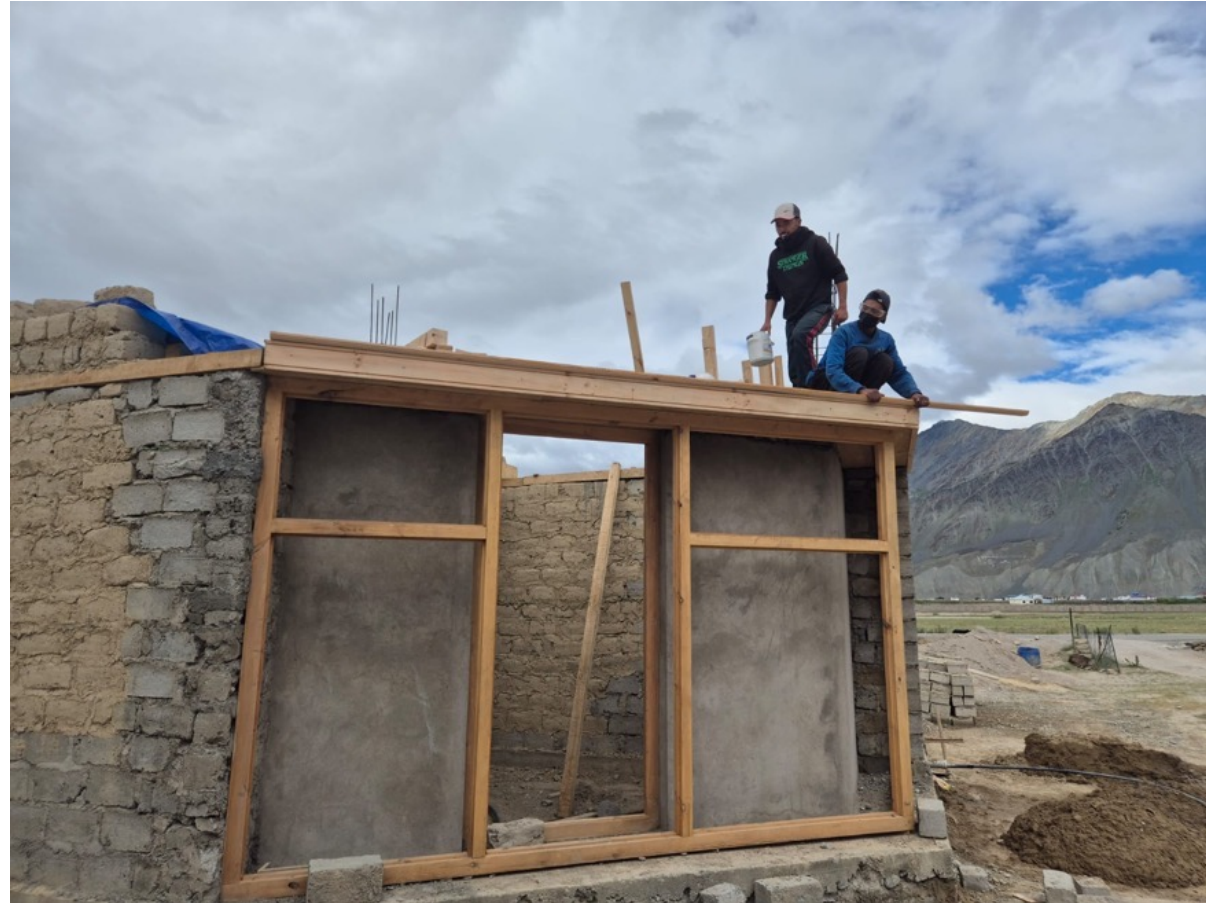
Installation of Exterior Windows

The installation of exterior windows has commenced for the side rooms. Skilled technicians are carrying out the process with precision, ensuring proper alignment and positioning. A water level pipe is employed to verify both horizontal and vertical alignment, thereby guaranteeing accuracy and uniformity across all window Frames.

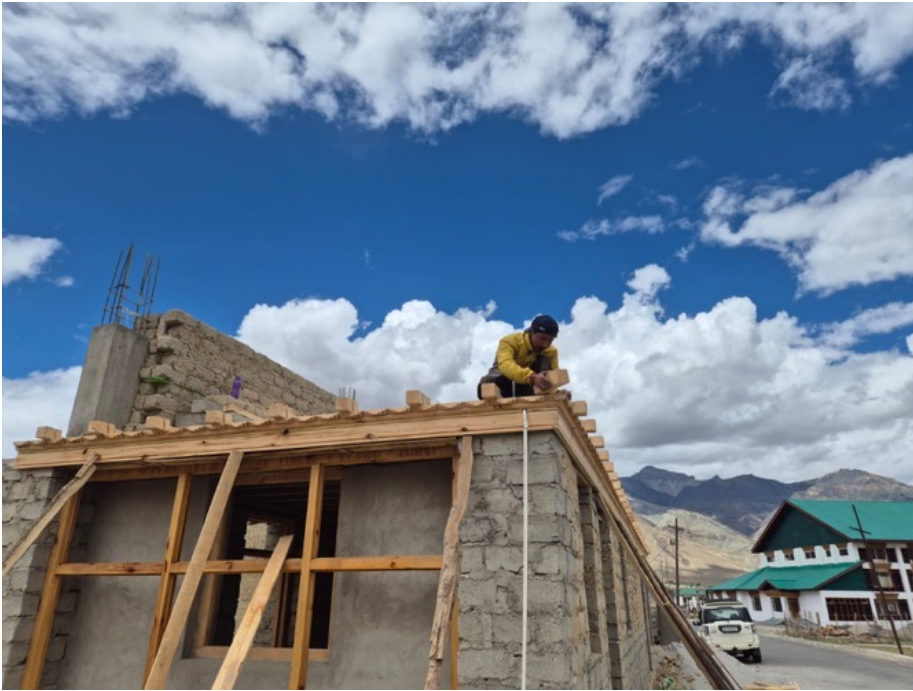
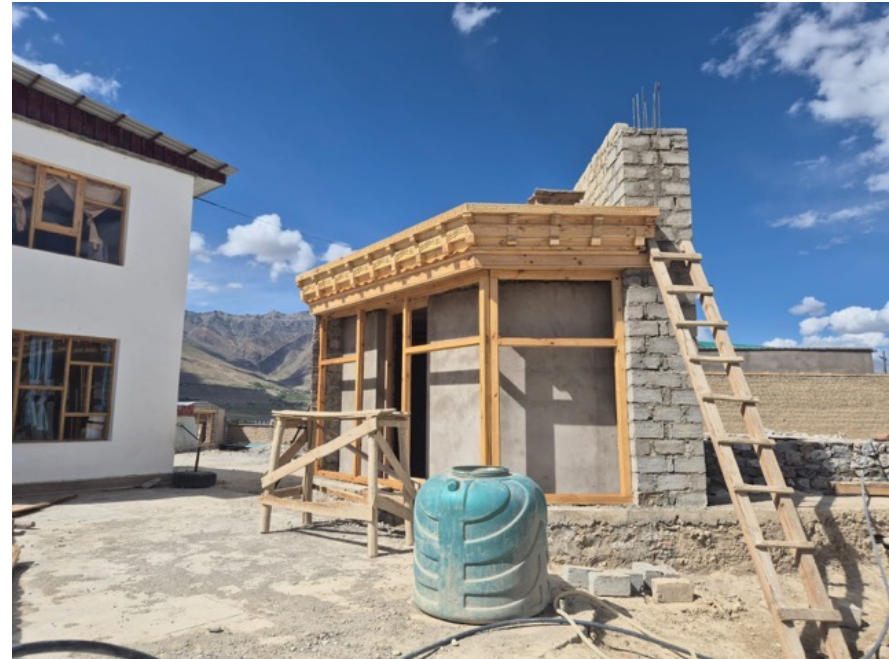
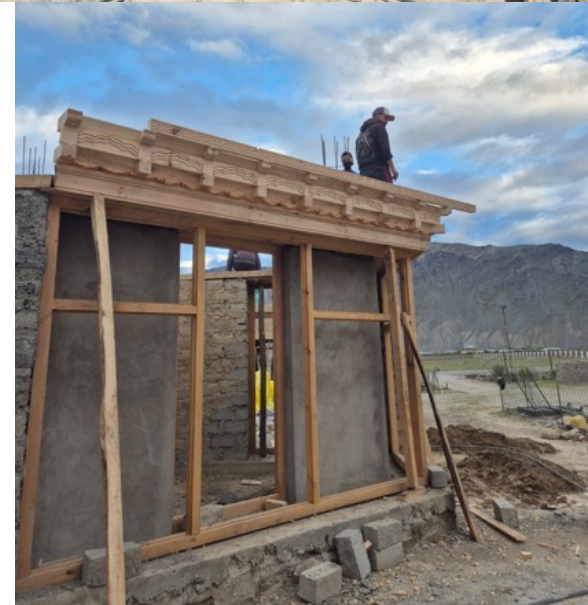
Installation of Traditional Shinsak

To preserve the cultural aesthetics of the building, local carpenters have installed **Shinsak** (traditional carved wooden elements) over the exterior windows. These handcrafted wooden details not only enhance the architectural character of the structure but also reflect the traditional craftsmanship of the region.

The Shinsak elements have been securely fixed above the window frames, ensuring both durability and alignment with the overall façade design. This integration of traditional artistry with modern construction provides the building with a distinctive cultural identity while maintaining functional performance.

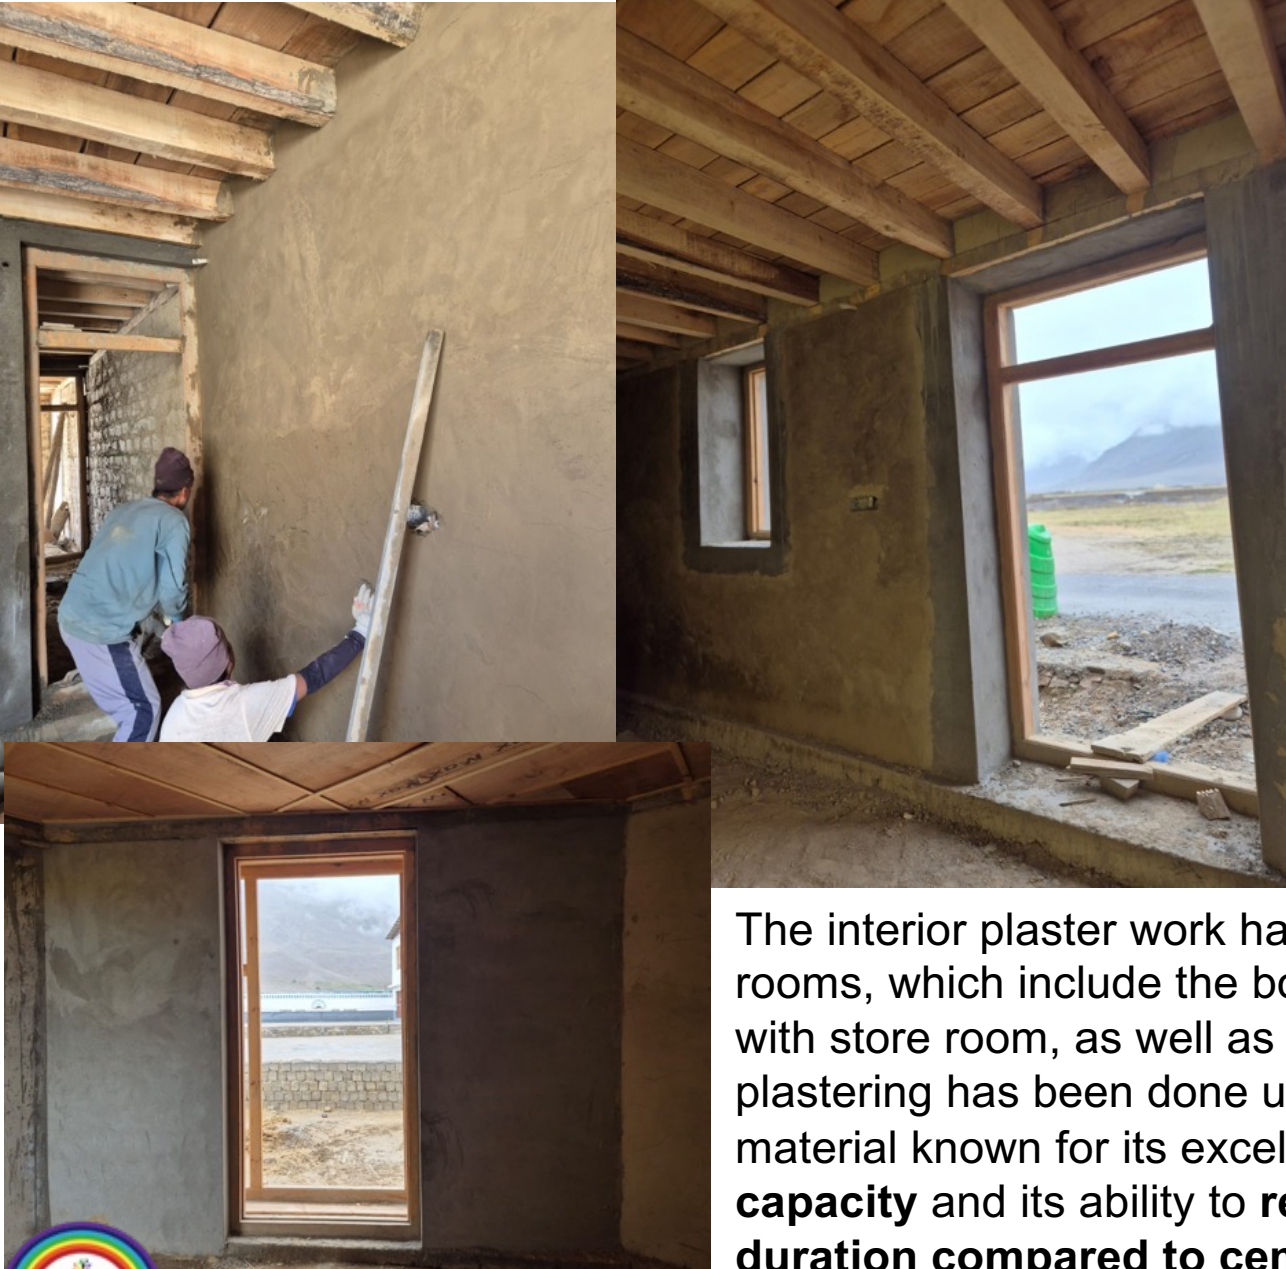
Interior Plaster Work Update

The interior plaster work has been completed in the side rooms, which include the boys' and girls' changing rooms with store room, as well as the cafeteria and kitchen. The plastering has been done using **mud plaster**, a traditional material known for its excellent **moisture absorption capacity** and its ability to **retain temperature for a longer duration compared to cement**.

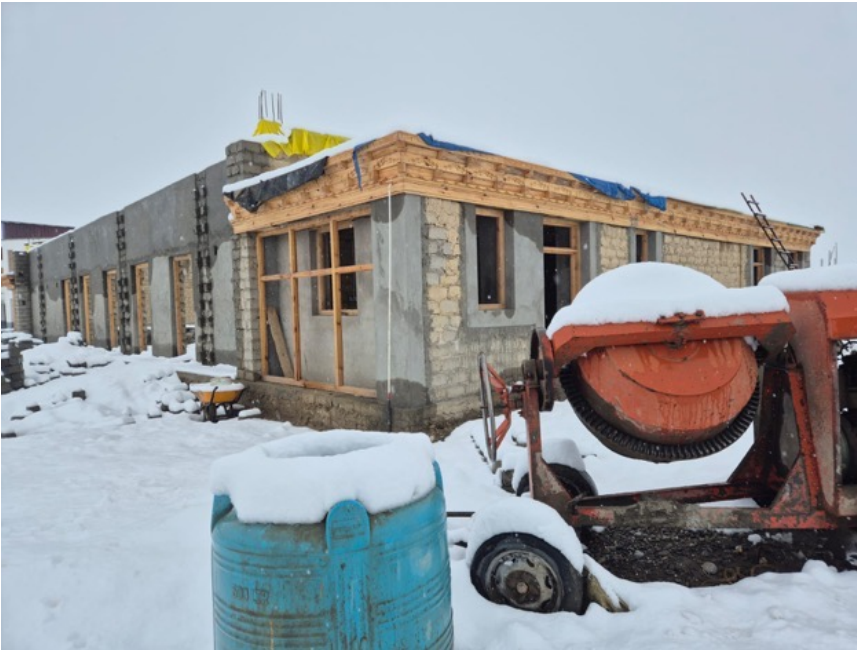
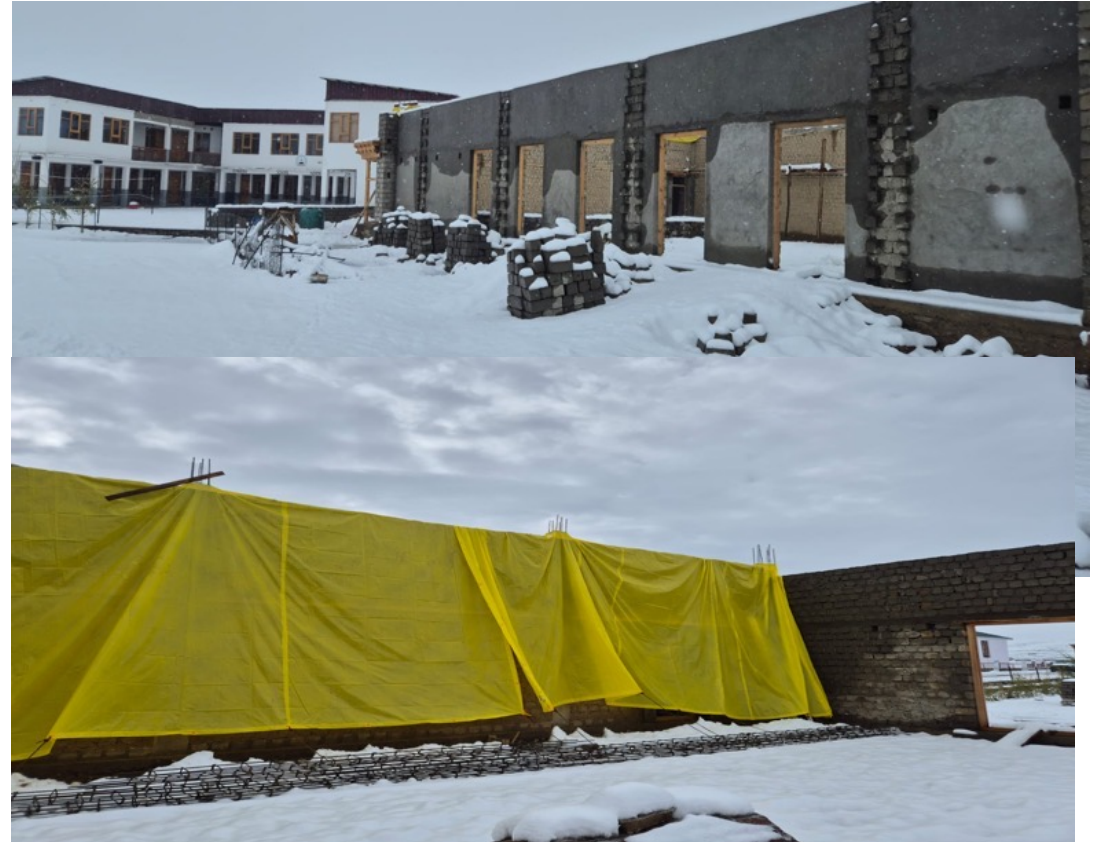
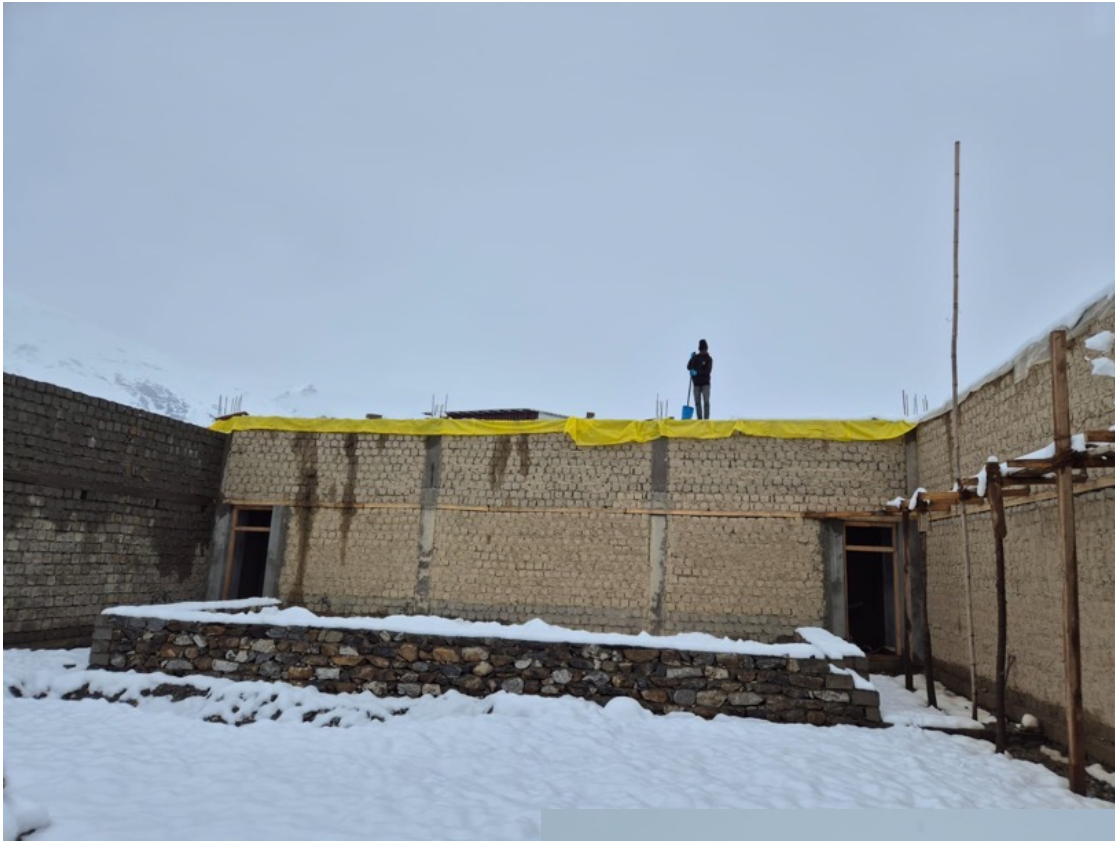
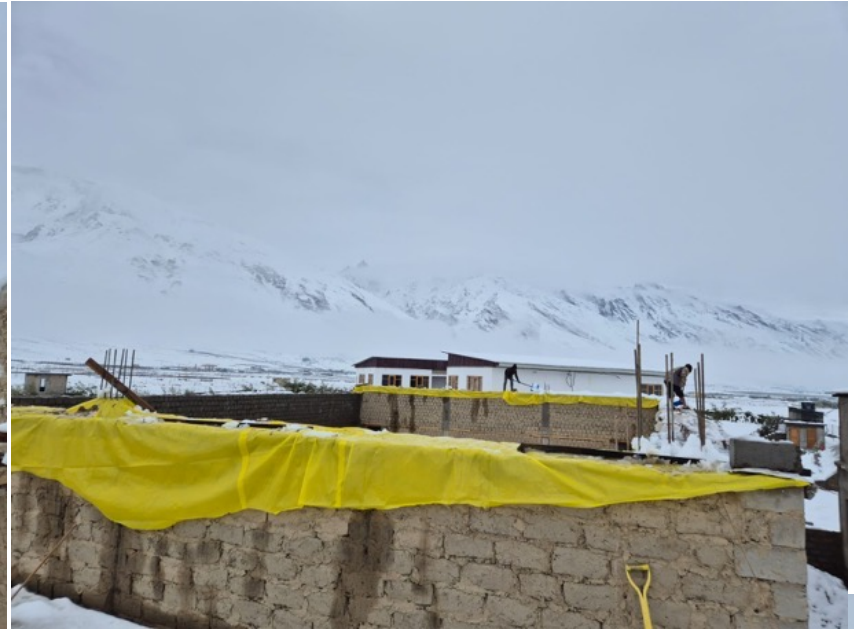
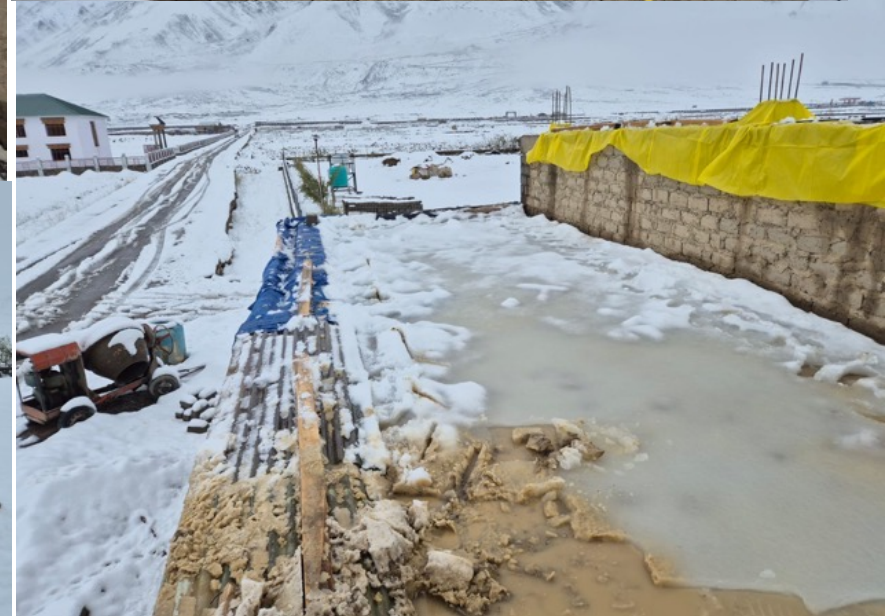
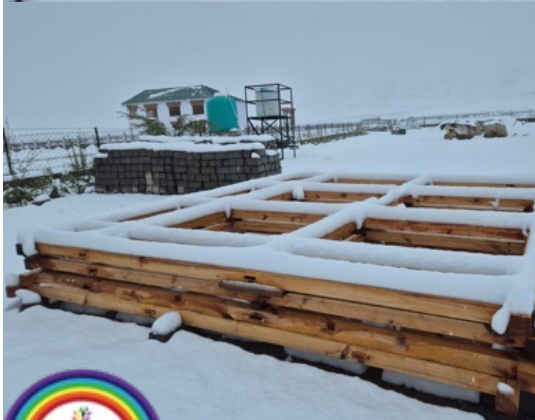
Impact of Unseasonal Weather on Work Progress

Construction activities were adversely affected due to unseasonal weather conditions beginning on **25th August**, when Ladakh experienced **four consecutive days of heavy rainfall** followed by **two days of unexpected snowfall**. Against the normal average rainfall of **15 mm in August**, the region recorded an unprecedented **47 mm**, leading to widespread disruption. The excessive rainfall and snowfall resulted in flash floods, causing damage to roads and bridges across Ladakh. The situation was further compounded as **Manali, Himachal Pradesh** emerged as one of the worst-affected areas, with road connectivity from **Delhi to Manali** remaining cut off to date. This has directly impacted the timely transportation of construction materials and supplies to the site, leading to unavoidable delays in the progress of work

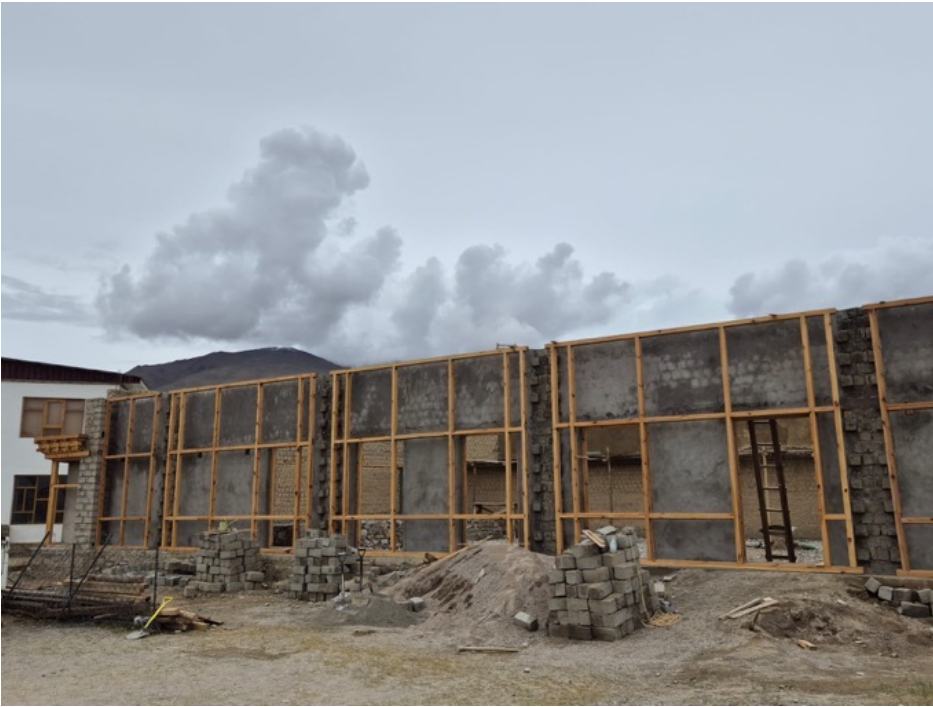
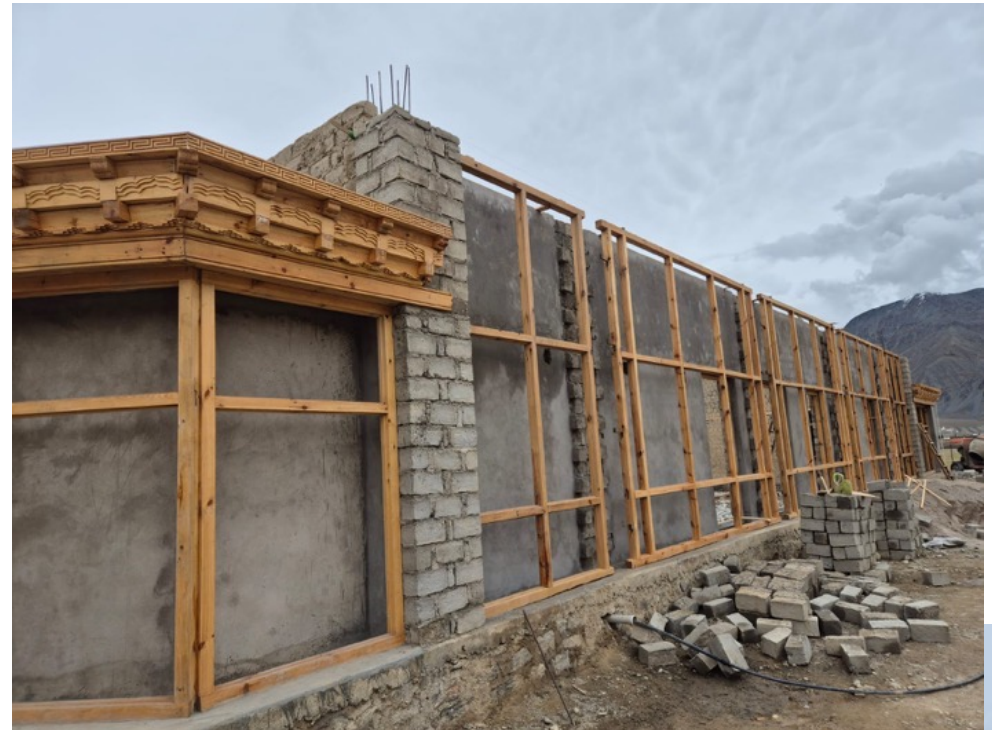
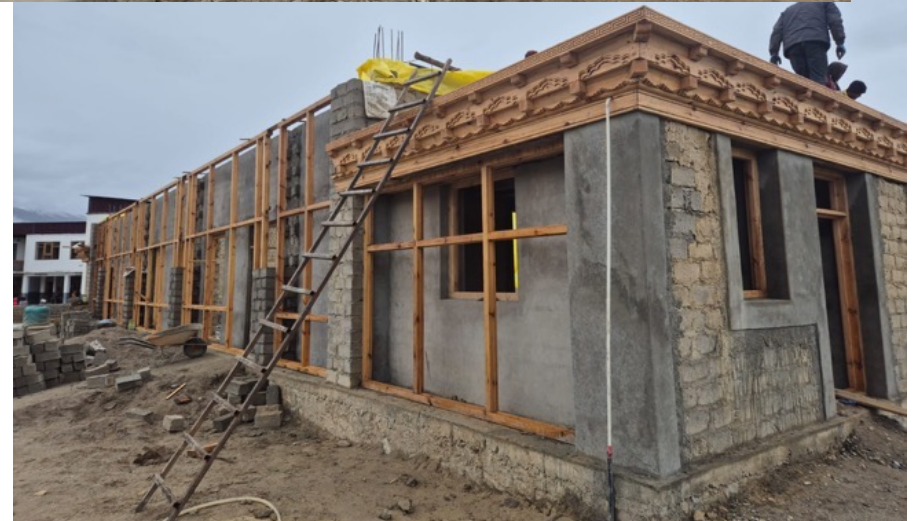
Status of Work as on 02/09/2025

We are pleased to report that the **brickwork for all sides of the building has been fully completed**. The project has now progressed to the **plastering phase** for both the exterior and interior façades.

Additionally, the **boys' and girls' changing rooms, cafeteria, and kitchen** have reached completion with respect to major structural works, including roofing and plastering. These milestones mark significant progress towards the overall completion of the project and set the stage for subsequent finishing works.
